Advanced NDE inspection methods for detection of SCC in blade attachments and blade roots

Hans RAUSCHENBACH¹; Michael CLOSSEN¹; Michael OPHEYS¹; Michael SIEGEL¹

¹ Siemens Power Generation, Mellinghofer str. 55; 45473 Mülheim ; Germany

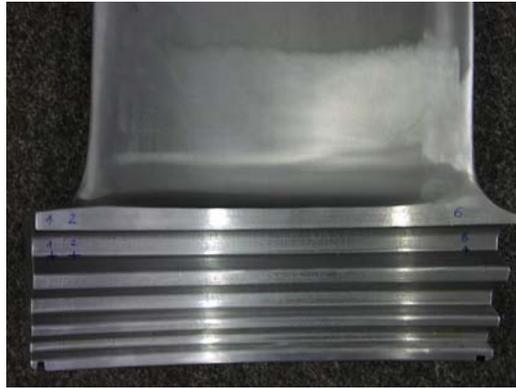
Figure 1
Blade root of an LP turbine rotor with artificial flaws, pressure side

Figure 1 und 2 show the root for such a blade. Performance of the inspection on the blade

Reference reflectors (grooves, 3 mm long, 1 mm deep) were introduced into these calibration blocks at the most-highly-stressed areas. These areas can be found on the pressure side in the vicinity of the leading/trailing edge of the blade root in the first serration of the fir-tree root as well as in the middle of the first serration on the suction side of the blade root.

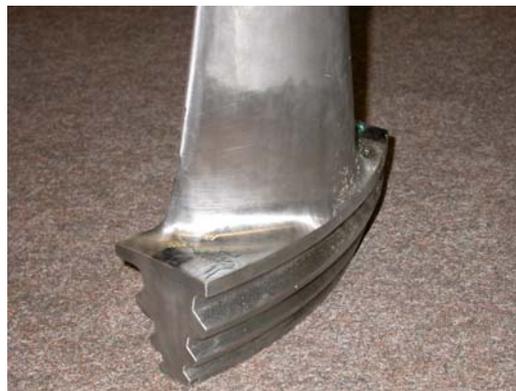
Figure 2
Blade root of an LP turbine rotor with artificial flaws, steam outlet area

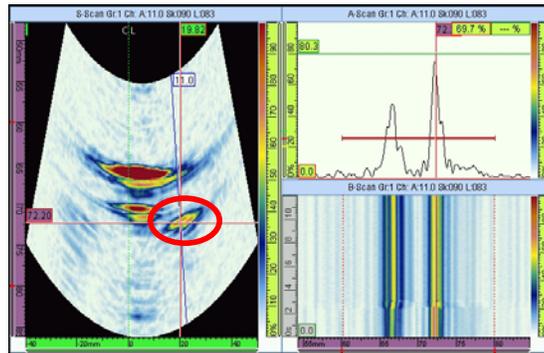
Figure 3
Scanning position : center, right hand blade flaw # 3

For all reflector positions, comparison measurements were performed both on the calibration blocks with artificial defects as well as on identical defect-free calibration blocks. The investigations were performed using the OMNISCAN (ZETEC) phased array examination system. Figs. 3 and 4 show an example of the documented sector scans for a selected scanning position.

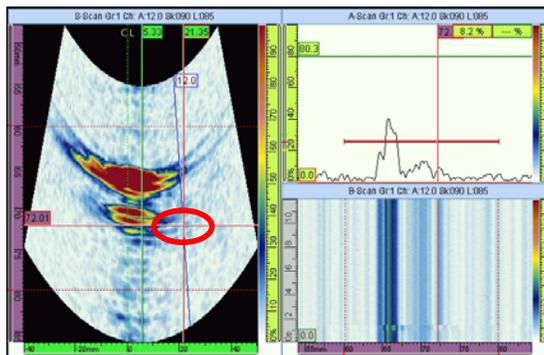
Figure 4
Scanning position 1, right hand blade, without artificial defect

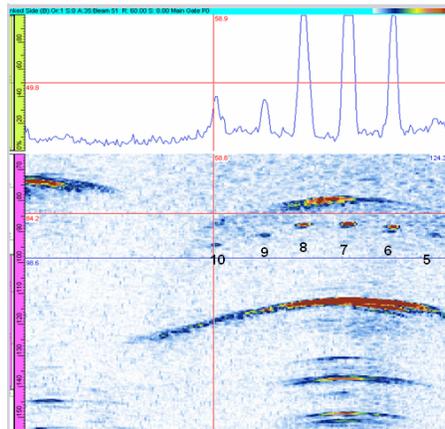
Figure 5
B-Scan of a mechanised Phased Array Inspection of an LP blade root (Siemens design)

Based on the experience of app. 30 Phased Array blade root inspection in the field further improvement of the inspection technique was reached by implementation of a mechanized inspection technique. A small manipulator ensure an encoder driven movement of the Phased Array probe. The UT data will be recorded online. So the complete serration of the blade root is covered by Phased Array UT inspection. Fig. 5 shows an example of Phased Array UT results of an mechanized Phased Array Blade Root inspection of an LP blade root. In this case 6 artificial notches in different positions (flaw# 5, 6, 7, 8, 9 and 10) were detected reliable. The implementation of mechanized Blade Root inspection in turbine field service will increase the covered areas in the blade root and improve reliability detectability.

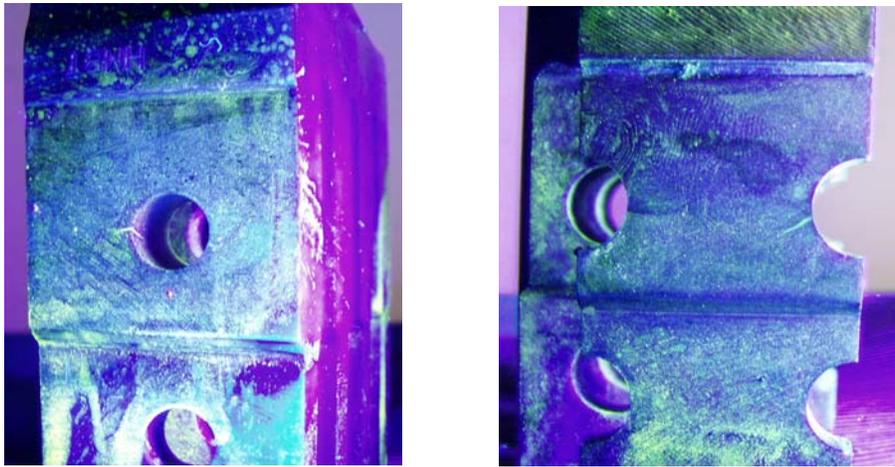
Figure 6 + Figure 7
Pinned blade roots, cracked in upper pin hole

It is known that incipient cracking can occur in the area of the pin holes under certain conditions in pinned blade roots. In contrast to blade roots with firtree design (where the probable orientation of anticipated cracks is known), the examination of pinned blade roots is complicated, as in this case cracks can develop with various orientations, which has a significant effect on detectability by ultrasound. Previously, the examination of such blade roots was performed primarily by means of conventional UT examination, which resulted in a relatively large number of errors in detection and size estimation due to the conditions described. The development of a phased-array ultrasonic examination method is described below which enables detection and size estimation of cracks in pinned blade roots. The examination method must be capable of reliably detecting incipient cracks, and determining their size.

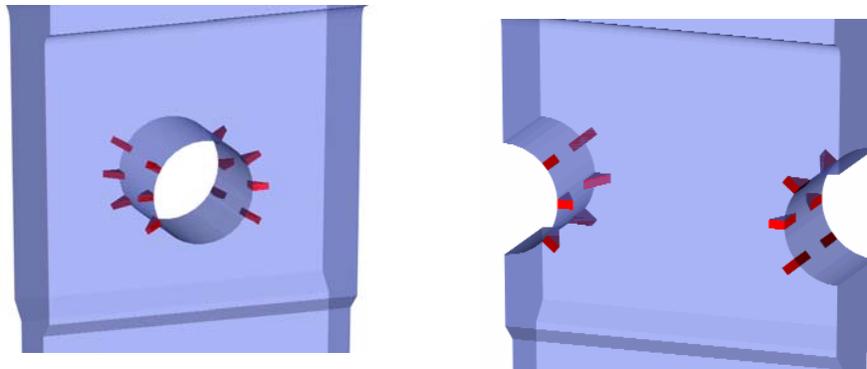
Figure 8 + Figure 9
Calibration blocks for blade rows 4 and 5 with artificial defects

After studying the examination problem, it was decided to solve it using phased-array ultrasonic examination. In order to accommodate the task definition, it was necessary to prepare a large number of calibration blocks. The calibration blocks represent the geometry of the outer fingers of the blade roots in rows 4 and 5 of the LP turbine shaft. Artificial defects of various sizes and with various orientations were introduced in the area of the upper pin hole.

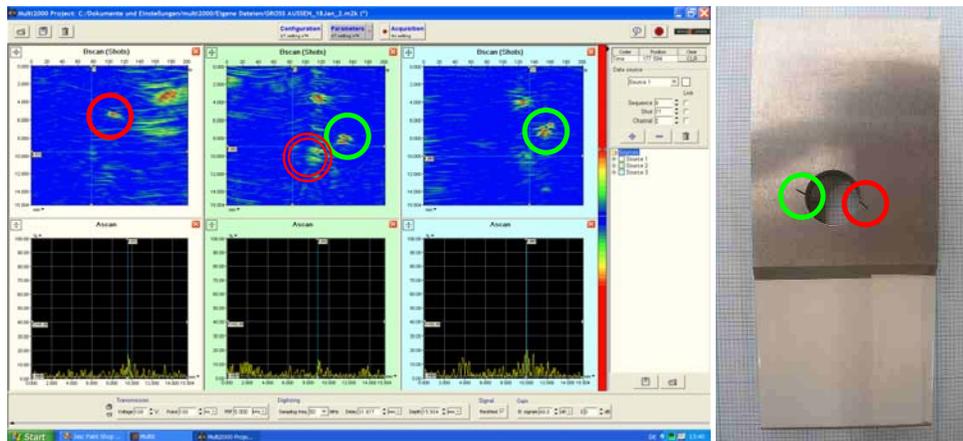
Figure 10
Examination result for the example of a calibration block with two artificial defects on the inside

of artificial defects with that of natural cracks. The tests were performed using the Multi- X (M2M) phased-array system. Two wedges were used to enable the detection of incipient cracks both in the area of the outer end face of the outer finger as well as in the area of the inside of the outer finger of the blade root. These wedges yield the respective beam angles which are specifically required for scanning of the inside or outside of the finger of the blade root. All of the shots in a sequence are displayed as a B-scan. A total of 3 B-scans are visible (Fig. 10). This examination method enables evaluation of the entire anticipated defect area with a single placement of the probe. Fig. 10 shows the examination of a calibration block for blade row 4 as an example, with 2 artificial defects at different angles on the inside. (notch, edge length: 2 mm, orientation: $+30^\circ$ (green) as well as 2 mm at an orientation of -45° (red).
